TRAX FARM DAM

PHASE I INSPECTION REPORT
NATIONAL DAM INSPECTION PROGRAM

JULY 1981

TRAX FARM DAM
WASHINGTON COUNTY, COMMONWEALTH OF PENNSYLVANIA
NDI NO. PA 00131
PennDER NO. 63-96

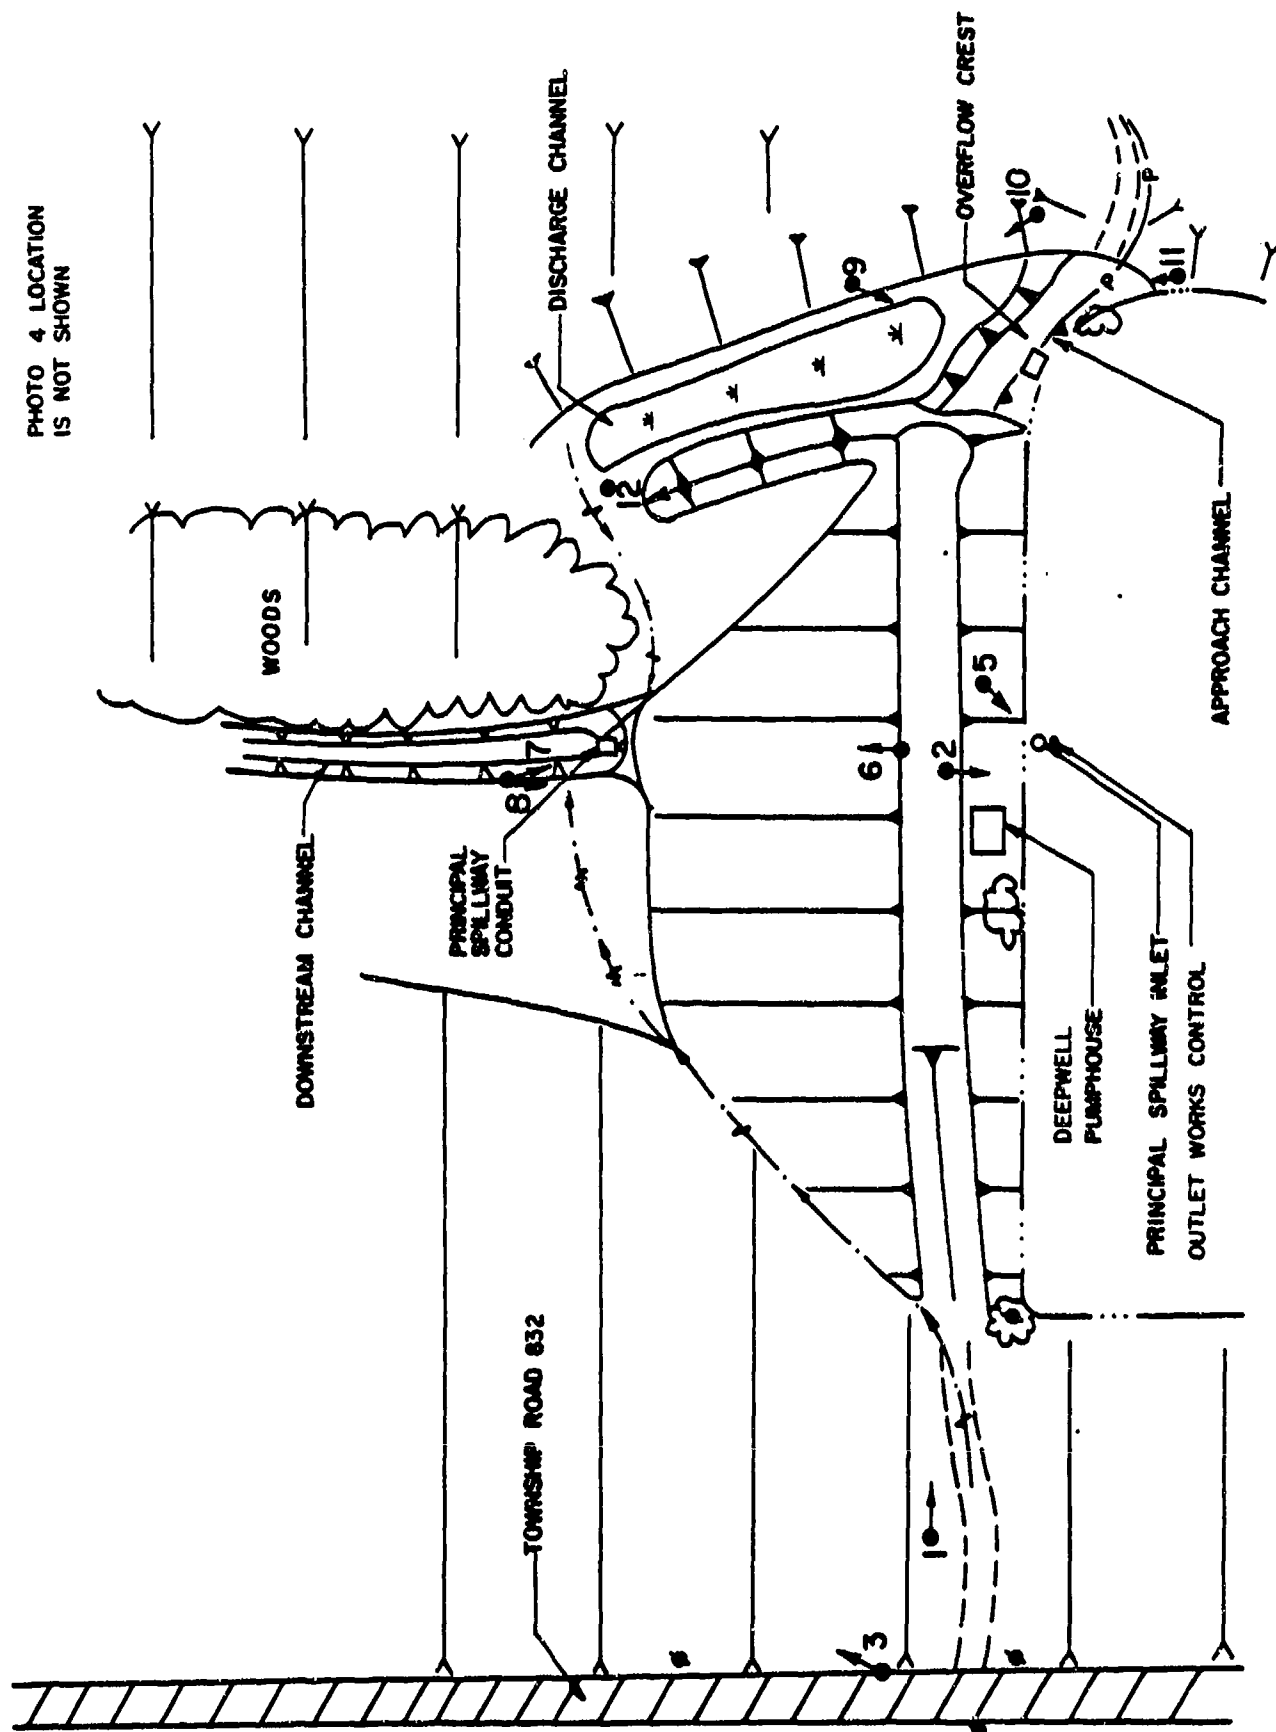
PHOTO 4 LOCATION
IS NOT SHOWN

- Photo 1 Embankment Overview from left abutment.
- Photo 2 Reservoir Overview from embankment crest.
- Photo 3 Downstream Hazards. Inhabited dwelling and Township Route 755.
- Photo 4 Downstream Hazard.
- Photo 5 Principal Spillway Intake Facility. Cap covers outlet works valve control stem.
- Photo 6 Principal Spillway Discharge Channel.
- Photo 7 Principal Spillway Conduit at outlet.
- Photo 8 Downstream Slope. Truck is on embankment crest.
- Photo 9 Emergency Spillway. Note pump and water supply pipeline across approach channel.
- Photo 10 Emergency Spillway Discharge Channel.
- Photo 11 Emergency Spillway Overflow Crest.
- Photo 12 Wet Condition at Emergency Spillway Discharge Channel Outlet. Note water flowing from wet area in discharge channel.

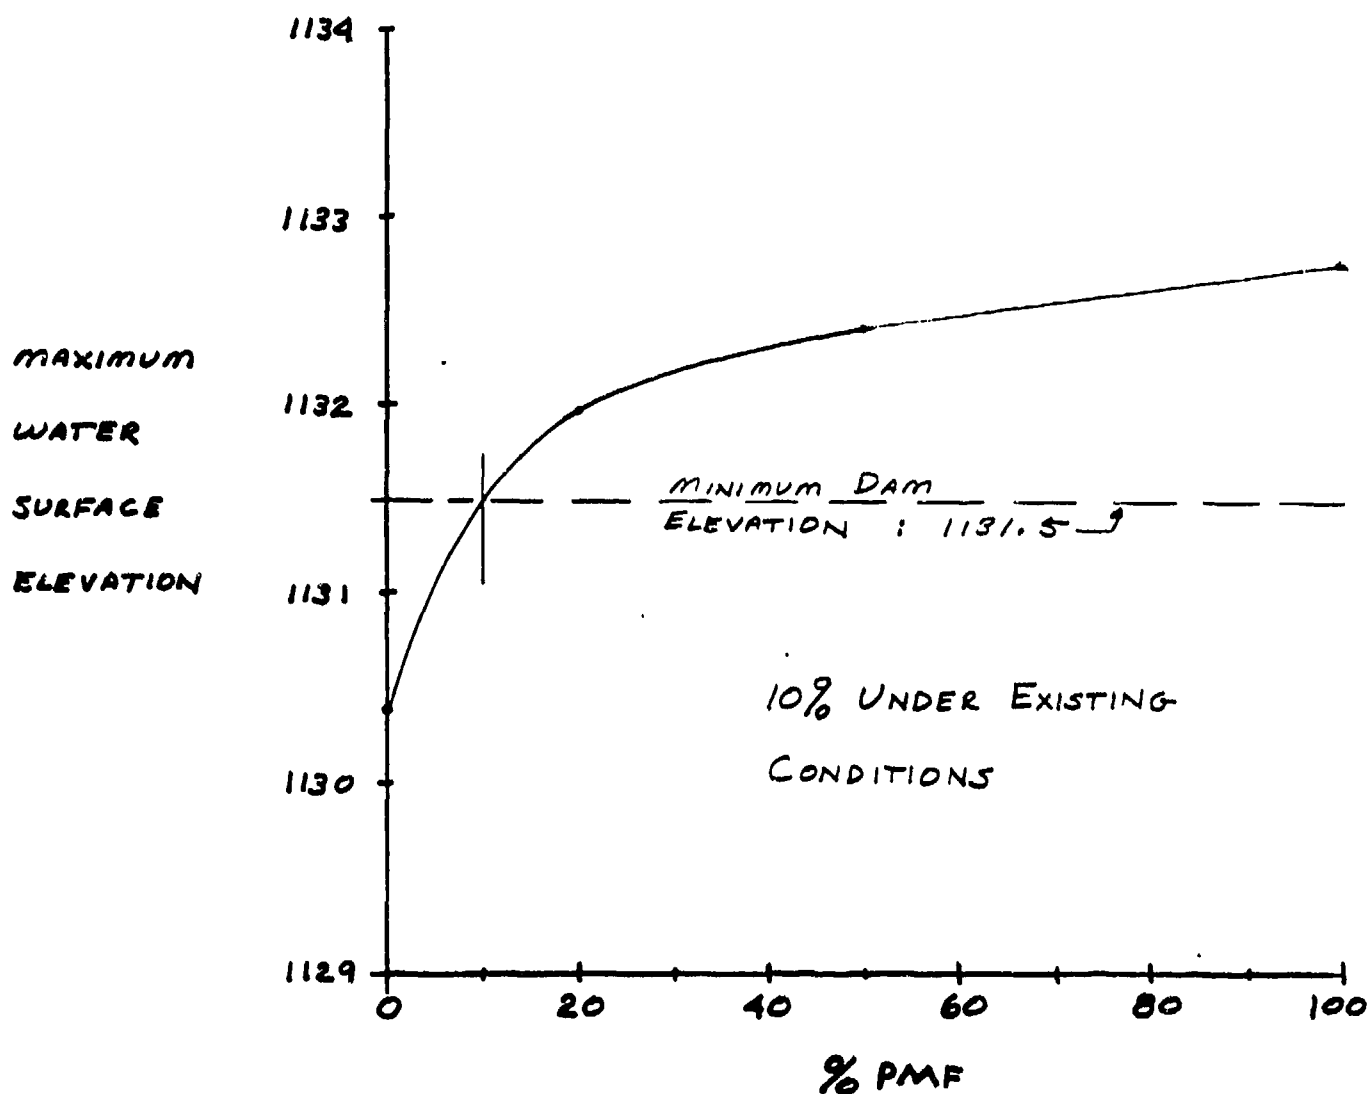
Job TRAX FARM DAM Job No. 80138-I
Subject HYDROLOGIC PERFORMANCE PLOT
Made By SGM Date 8/2/81 Checked JEB Date 6/18/81

Trax Farm Dam is a "small" size, "high" hazard structure. Corps of Engineers guidelines recommend the one half to one times the Probable Maximum Flood (PMF) as the Spillway Design Flood for a "small" size, "high" hazard dam. Trax Farm Dam's Spillway Design Flood is one half the Probable Maximum Flood. Spillway capacity is "inadequate" because the non-overtopping flood discharge was found, by using the HEC-1 computer program, to be 10 percent of the PMF.
